PRELIMINARY NONDESTRUCTIVE EVALUATION MANUAL FOR THE SPACE SHUTTLE

**PRELIMINARY NONDESTRUCTIVE EVALUATION MANUAL
FOR THE SPACE SHUTTLE**

APPENDIX TO FINAL REPORT

**LOCKHEED-GEORGIA COMPANY
A DIVISION OF LOCKHEED AIRCRAFT CORPORATION
MARIETTA, GEORGIA 30063**

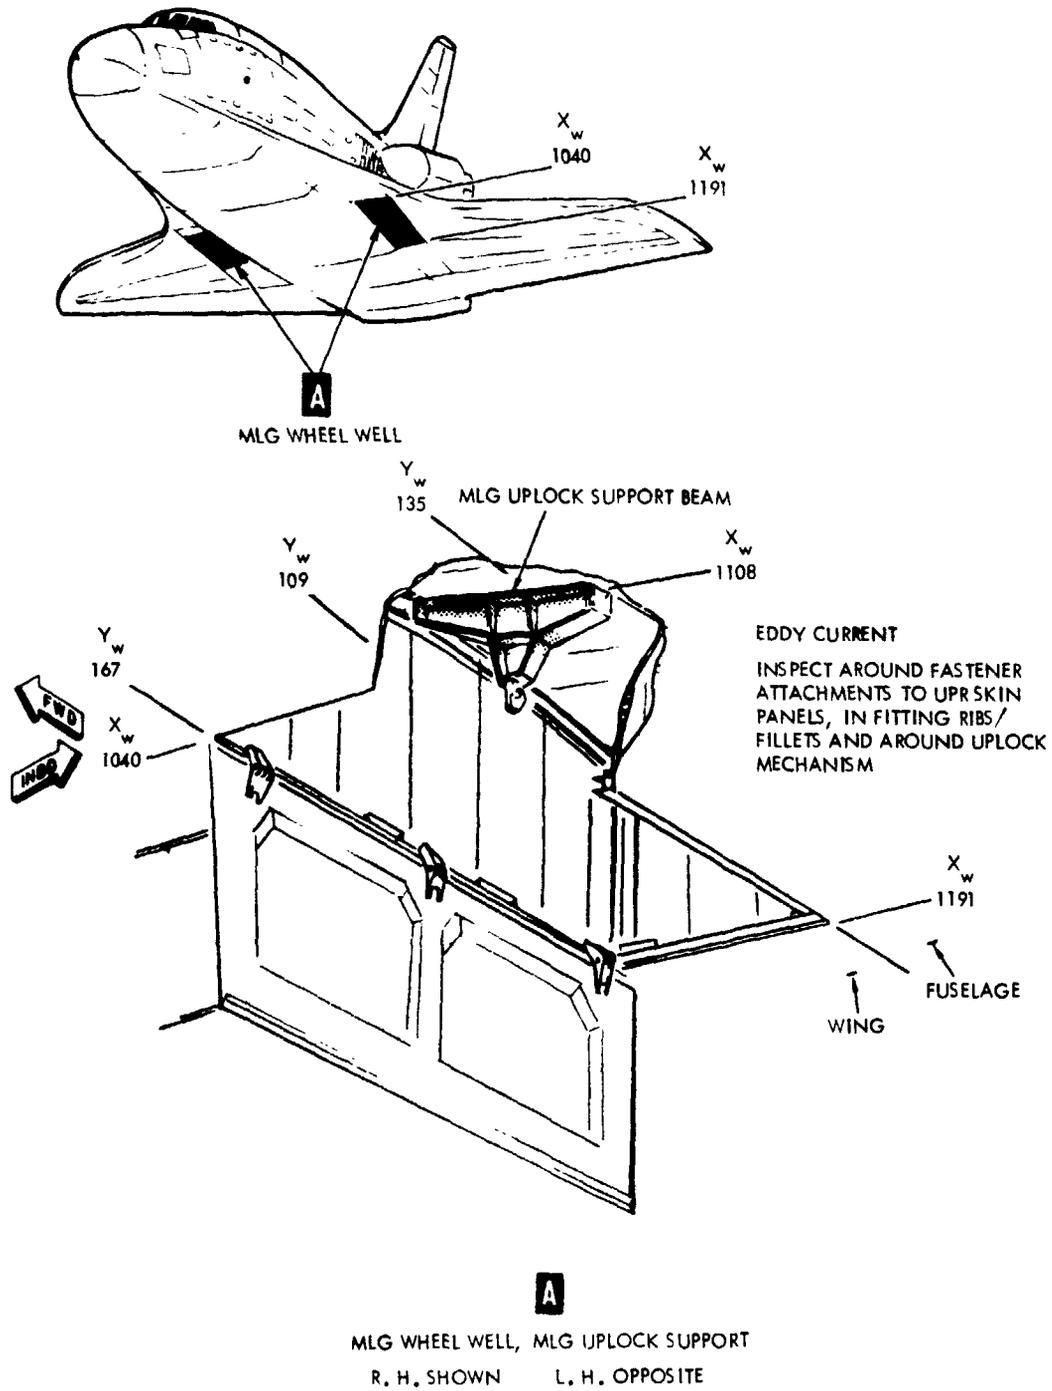
Figure 5-3. MLG Main Strut Uplock Support Beam

DEFECTS: Fatigue cracks may occur in the root area where the fitting joins the support beam, also where the beam reinforcements tie into the wing upper skin.

NDT TECHNIQUES: Primary: Eddy current surface probe (para. 1.5.4.4) for areas on up-lock support beam and fitting.

Backup: Fluorescent penetrant (para. 1.5.2.1 Fig. 1-9)

PROCEDURE NO. 5-603, Figure 5-3

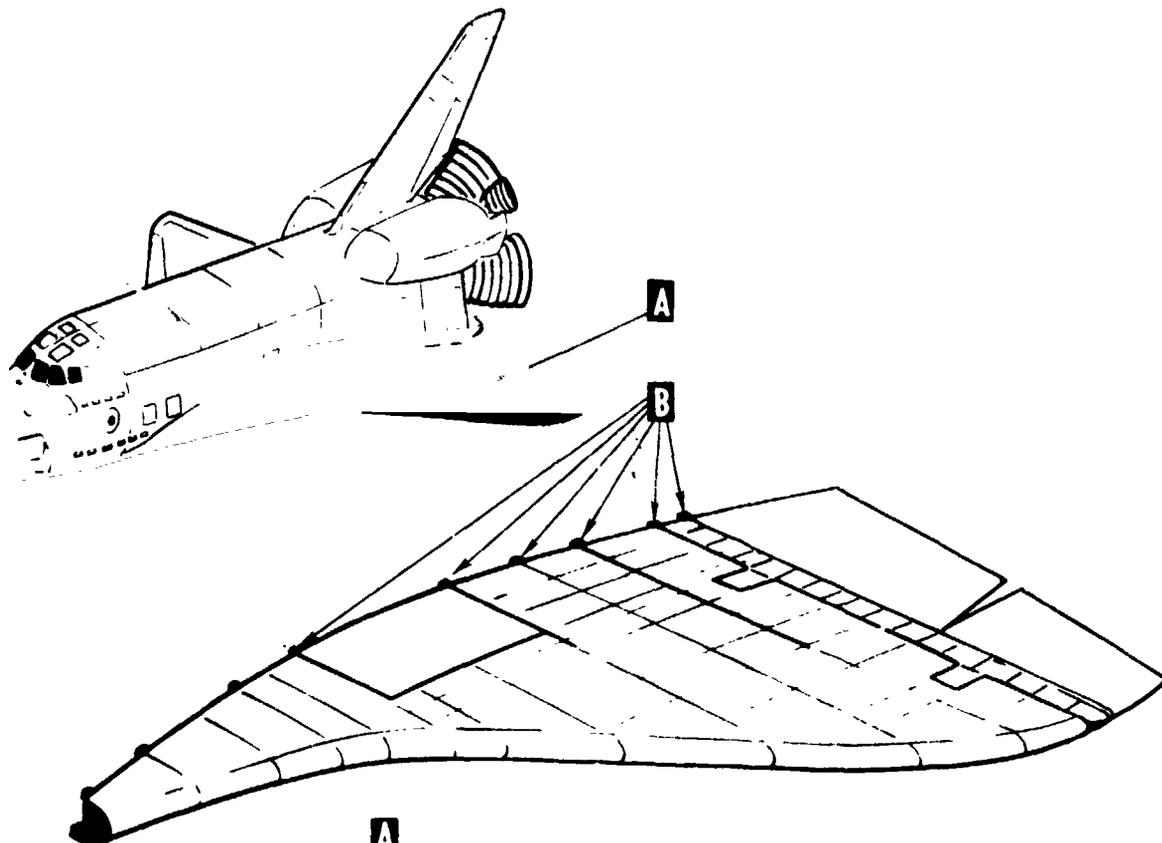
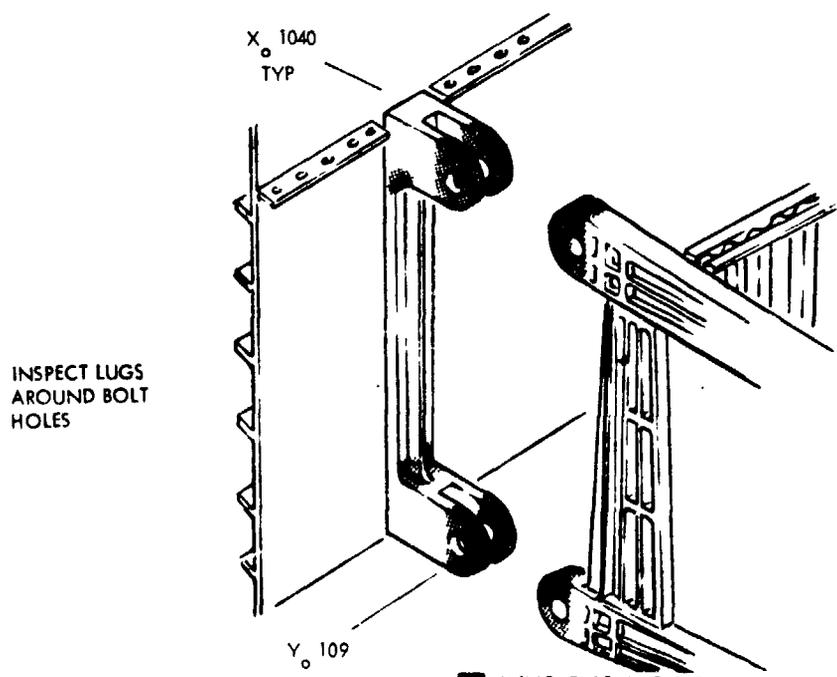
Figure 5-4. Clevis Attach Fittings, Wing-to-Fuselage

DEFECTS: Fatigue cracks can occur in the bolt holes, upper and lower edge of hole; in forward and aft fittings, cracks may also occur in lug fillet where lug blends into base (on fuselage).

NDT TECHNIQUES: Primary: Ultrasonic shear wave (para. 1.5.5.3 B) and eddy current surface probe (para. 1.5.4.4)

Backup: Eddy current bolt hole (para. 1.5.4.3) for clevis bolt holes, fluorescent penetrant (para. 1.5.2.1 Fig. 1-9) for other areas.

A
WING-WING/FUSELAGE INTERFACE

B WING-FUSELAGE CLEVIS ATTACH FITTINGS

PROCEDURE NO. 5-604, Figure 5-4

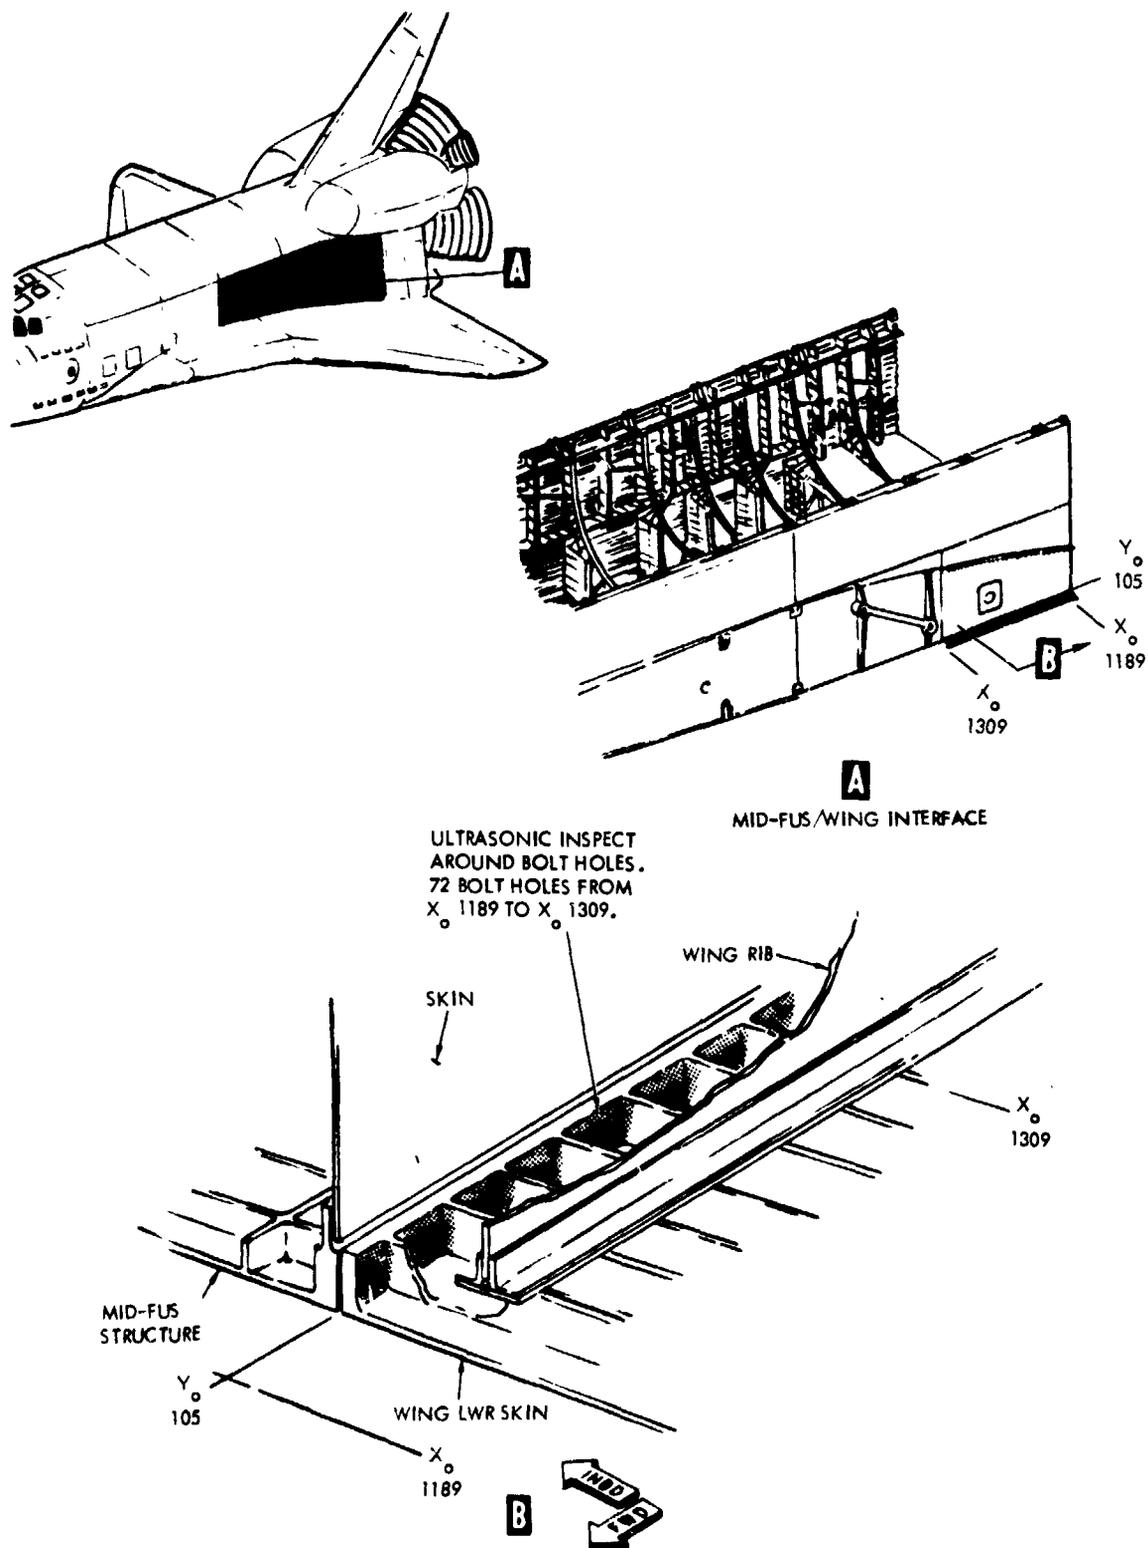
Figure 5-5. Wing Lower Wing/Fuselage Tension Tie

DEFECTS: Fatigue cracks may occur in the tension bolt holes in the base of the fitting.

ACCESS: Enter the main wing box aft of the MLG well through the wing/fuselage access opening. For backup inspection, the tension bolt must be removed. (NOTE: Remove tension bolts only in accordance with engineering concurrence and applicable service manuals).

NDT TECHNIQUES: Primary: Ultrasonic shear wave (para. 1.5.5.3 C)
Backup: Eddy current bolt-hole (para. 1.5.4.3)

PROCEDURE NO. 5-605, Figure 5-5

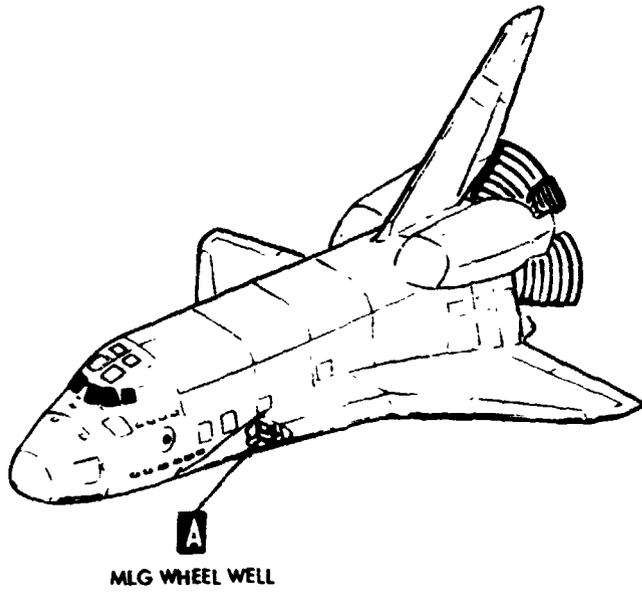
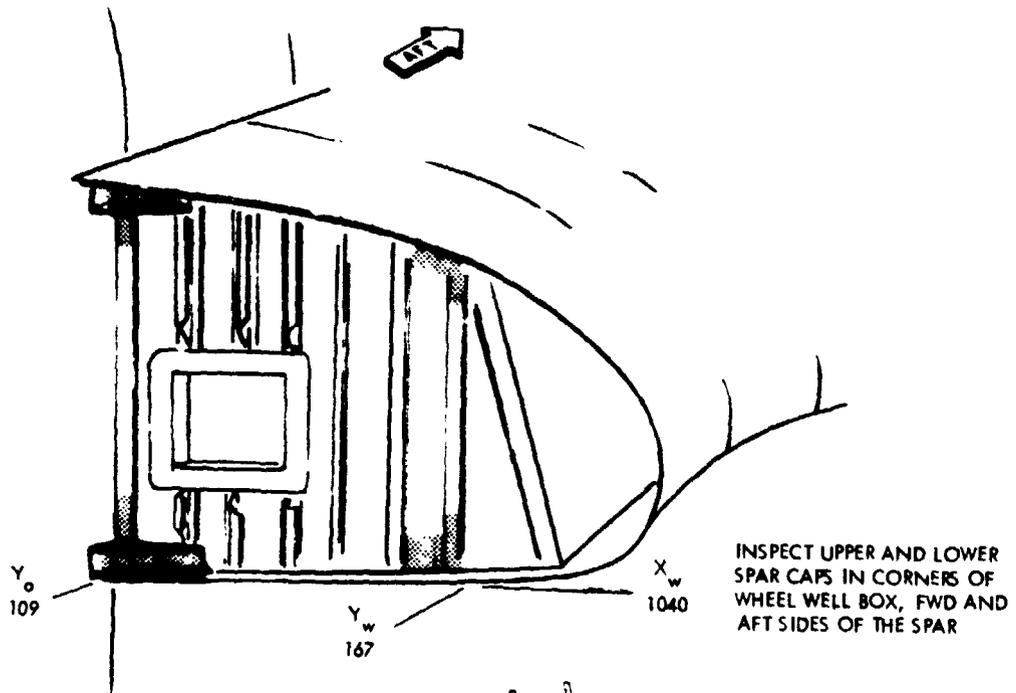
Figure 5-6. MLG Box Forward Spar

COMPONENT/AREA DESCRIPTION: MLG BOX FORWARD SPAR. The components of this spar are 2024 aluminum alloy with an abrasion-resistant polyurethane enamel surface finish within the MLG box. The spar is located at $X_{\circ} 1040$ and forms the forward wall of the box. It attaches to the mid-fuselage structure at $Y_{\circ} \pm 105$ through moment ties, to the MLG box outboard rib at $Y_{\circ} 167$ and to upper and lower wing skin panels. The spar caps (upper and lower) in the vicinity of these attachments should be inspected for fatigue damage induced by wing flight loads, landing and taxi loads.

DEFECTS: Radial cracks in spar cap attachment holes and edge cracks near the fuselage and outer MLG box rib attachments.

NDT TECHNIQUES: Primary: Eddy current (para. 1.5.4.4) and or ultrasonic shear wave (para. 1.5.5.3 C)

MLG WHEEL WELL FORWARD SPAR (FWD SIDE) AT X_w 1040
 L.H. SHOWN R.H. OPPOSITE

PROCEDURE NO. 5-606, Figure 5-6

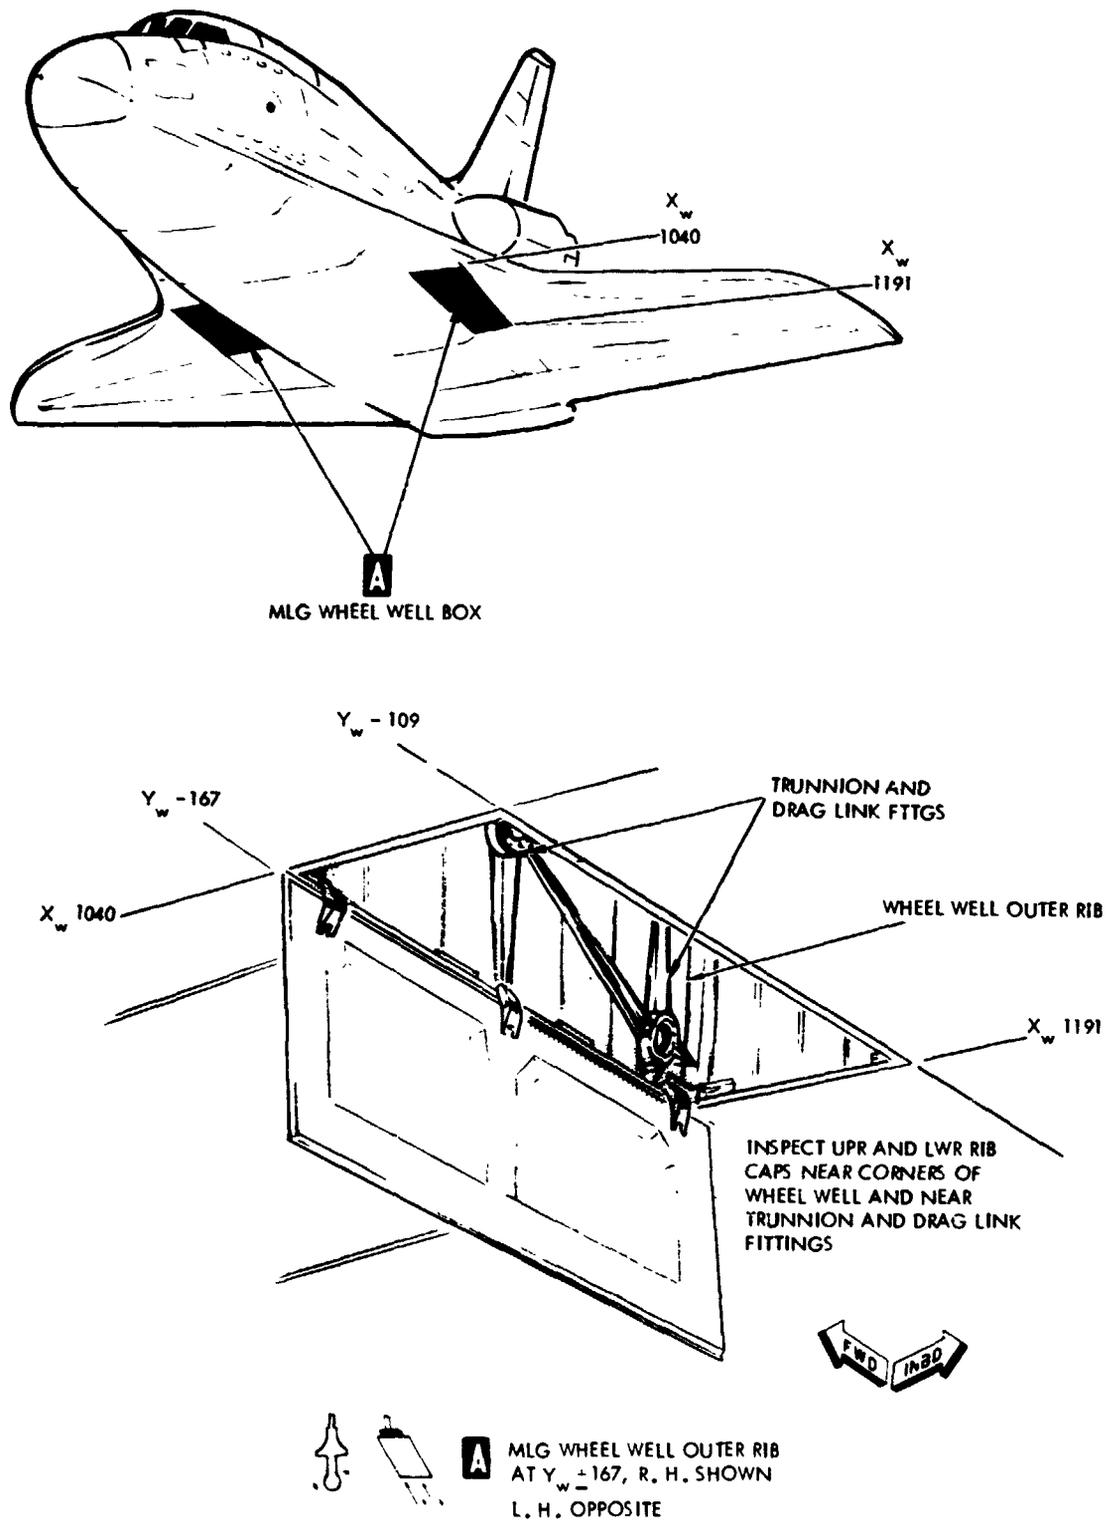
Figure 5-7. MLG Outer Rib-to-Wing Structure, Upper and Lower Attach

DEFECTS: Fatigue and overstress cracks can occur around fastener holes in the rib cap to wing panel stiffener area.

NDT TECHNIQUES: Primary: Eddy current surface probe (para. 1.5.4.4) and/or ultrasonic shear wave (para. 1.5.5.3 C)

Backup: Fluorescent penetrant (para. 1.5.2.1 Fig. i-9)

PROCEDURE NO. 5-607, Figure 5-7

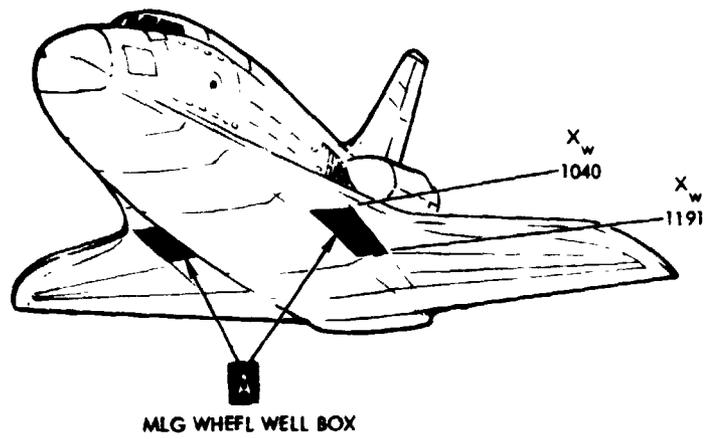
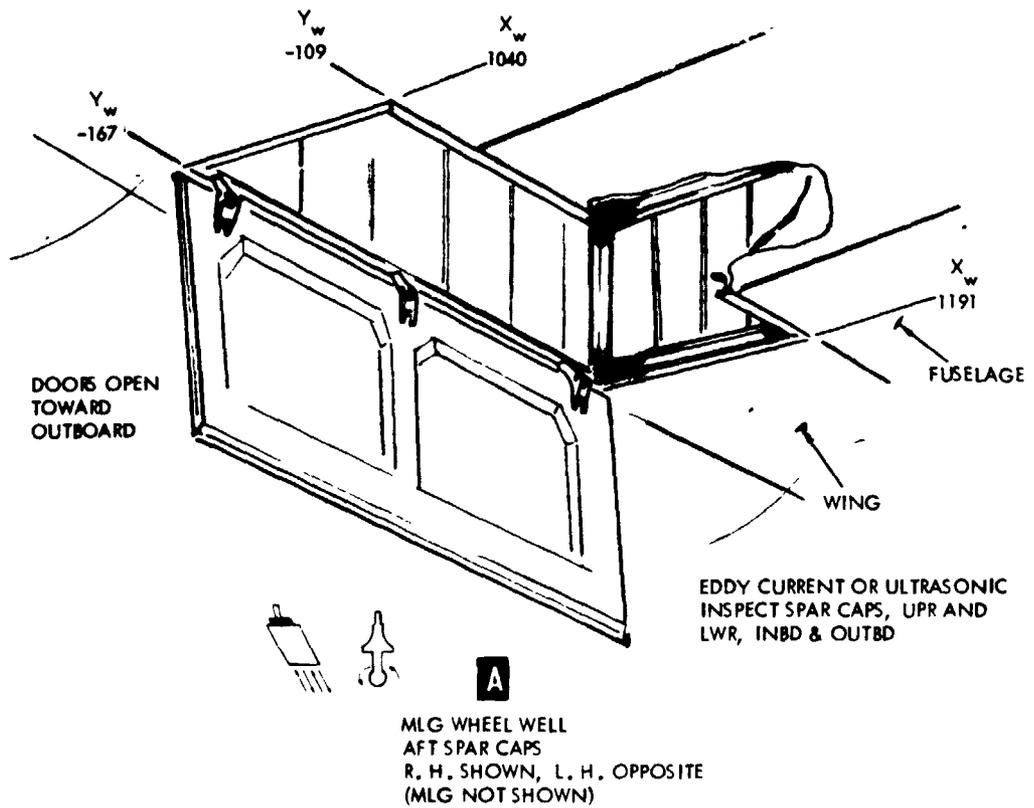
Figure 5-8. MLG Box Aft Spar Caps

COMPONENT/AREA DESCRIPTION: MLG BOX AFT SPAR CAPS. The components of this spar are 2024 aluminum alloy with an abrasion-resistant polyurethane enamel surface finish within the box. The spar, located at $X_{\circ} 1191$, forms the aft wall of the MLG box and attaches to the mid-fuselage structure at $Y_{\circ} \pm 105$, to the MLG box outboard rib at $Y_{\circ} \pm 167$, and to the upper and lower wing panel. It is also a portion of the wing front beam. The upper and lower spar caps in the vicinity of these attachments may become damaged due to wing flight loads, landing and taxi loads and debris kicked up by the landing gear.

DEFECTS: Radial cracks in spar cap attachment holes and edge cracks near the fuselage and outer MLG box rib attachments.

NDT TECHNIQUES: Primary: Eddy current (para. 1.5.4.4) and/or ultrasonic shear wave (para. 1.5.5.3 C)

PROCEDURE NO. 5-608, Figure 5-8

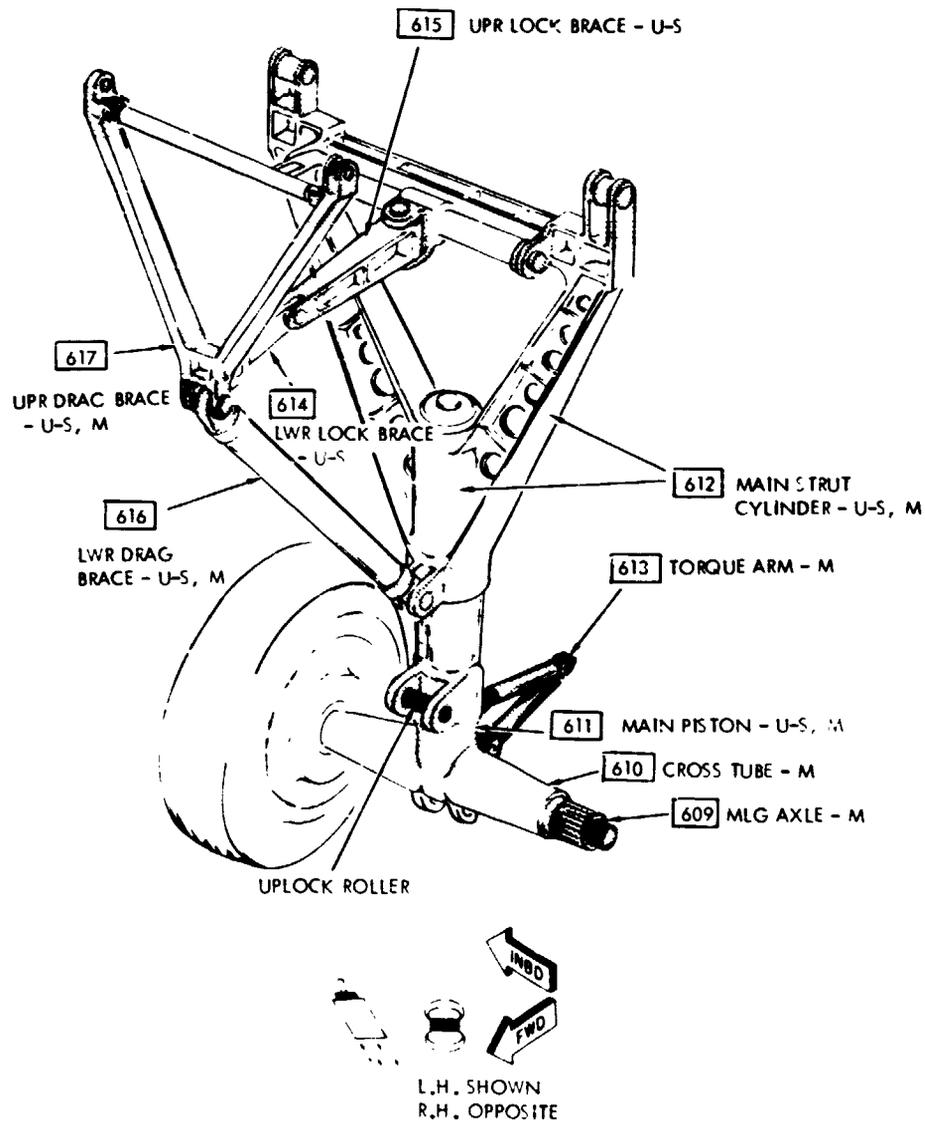
Figure 5-9. Main Landing Gear Assembly

COMPONENT/AREA DESCRIPTION: MLG AXLE. This component is machined from a 300M steel forging and has a (TBD) surface finish. The axle is subject to bending and shear loads during taxi turns and adverse landing conditions. Damage may occur to the splines or to the body of the axle. One per MLG.

DEFECTS: Cracked splines and circumferential cracks in the middle portion of the axle body.

COMPONENT/AREA DESCRIPTION: MLG CROSS TUBE. This cylindrical fitting is made of a 300M forging and has an abrasion-resistant polyurethane enamel surface finish. It houses the MLG axle and mates to the MLG piston. It is subject to tensile loads during reverse braking and shear loads during MLG retraction. This safe-life designed component may accumulate damage during landing and taxi or because of residual intrinsic or build-up stresses combined with a salt-laden atmosphere. One per MLG.

DEFECTS: Circumferential cracks near piston interface, longitudinal cracks near end, and longitudinal stress-corrosion cracks along forging parting plane.

DEFECTS: Circumferential cracks near the base of the upper piston region, longitudinal stress corrosion cracks along the forging parting plane, radial cracks around the torque link attachment, circumferential cracks near the piston-to-cross tube transition.

DEFECTS: Radial cracks in the lower drag brace mating lug and the retraction actuator lugs, circumferential cracks in the trunnion dowels and longitudinal stress-corrosion cracks along the forging parting plane.

- PROCEDURE NUMBER
 M - MAGNETIC PARTICLE INSPECTION
 U-S - ULTRASONIC SHEAR WAVE INSPECTION

INSPECT: LUG BOLT HOLES
 LUG BASE INTERSECTIONS
 AXLE SPLINES AND BODY
 MAIN CYLINDER PARTING PLANE
 MAIN PISTON PARTING PLANE
 CROSS TUBE BODY INTERSECTIONS

PROCEDURE NO. 5-609, Figure 5-9

PROCEDURE NO. 5-610, Figure 5-9

PROCEDURE NO. 5-611, Figure 5-9

PROCEDURE NO. 5-612, Figure 5-9

PROCEDURE NO. 5-613, Figure 5-9

PROCEDURE NO. 5-614, Figure 5-9

PROCEDURE NO. 5-615, Figure 5-9

PROCEDURE NO. 5-616, Figure 5-9

PROCEDURE NO. 5-617, Figure 5-9

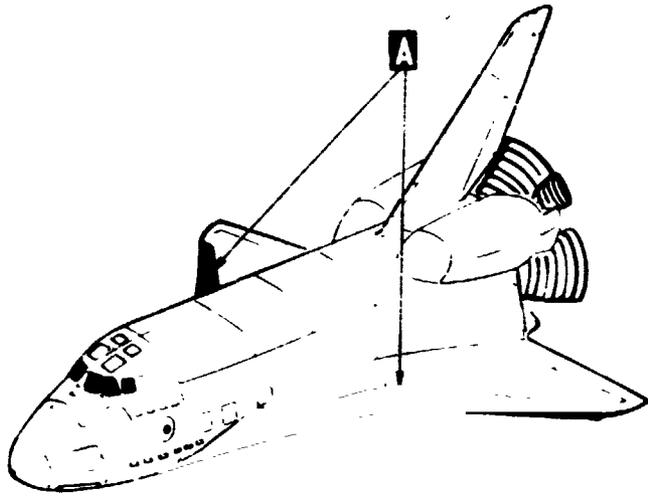
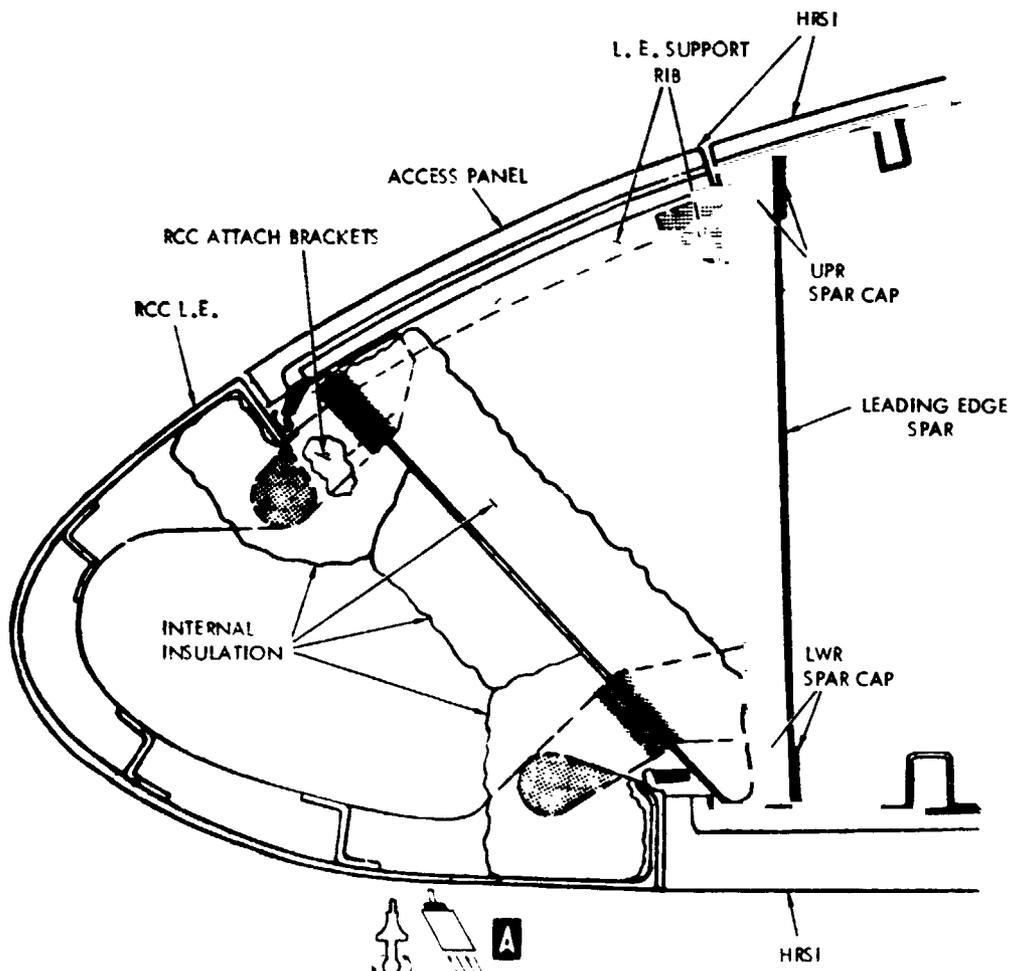
Figure 5-10. Leading Edge Spar Caps

These 2024-T81 aluminum alloy spar caps are located along the upper and lower edges of the wing leading edge spar, which forms the forward closure of the double-delta wing structure. The spar caps should be inspected at certain wing rib/spar attachment locations such as at Y_w 171.2 (X_w 1009.75), Y_w 184 (X_w 1040), Y_w 198 (X_w 1071.5), Y_w 254 (X_w 1132), Y_w 312.5 (X_w 1191), Y_w 372.5 (X_w 1249) and Y_w 435 (X_w 1307). The leading edge attach structure should be inspected generally along the wing from X_w 1040 aft. Fatigue damage may be induced in tension and shear by flight loads and high headwinds during high-Q boost.

DEFECTS: Radial cracks at fastener holes and edge cracks in the spar cap at the rib/spar attachment points; radial cracks at fastener holes in the leading edge attach structure.

NDT TECHNIQUES: Primary: Eddy current (para. 1.5.4.4) and/or ultrasonic shear wave (para. 1.5.5.3 C)

LEADING EDGE SPAR CAP AND LEADING EDGE ATTACH BRACKETS

PROCEDURE NO. 5-618, Figure 5-10

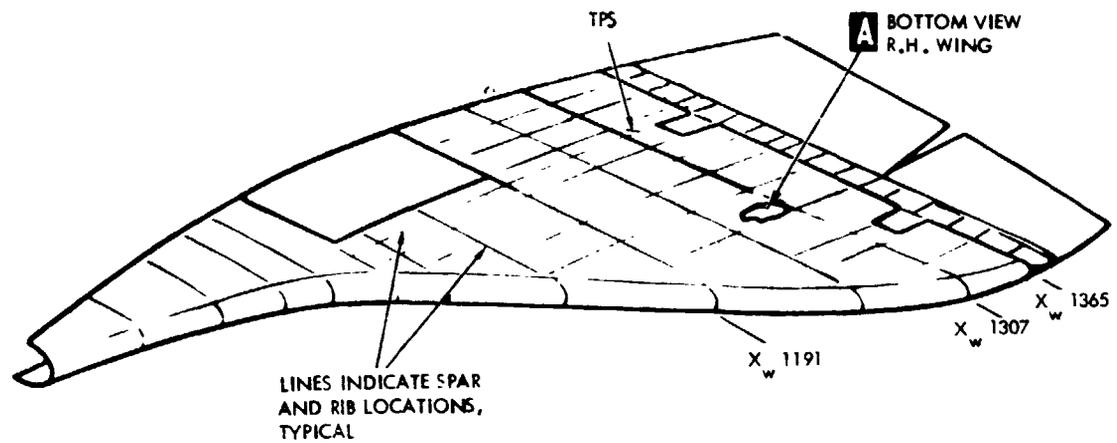
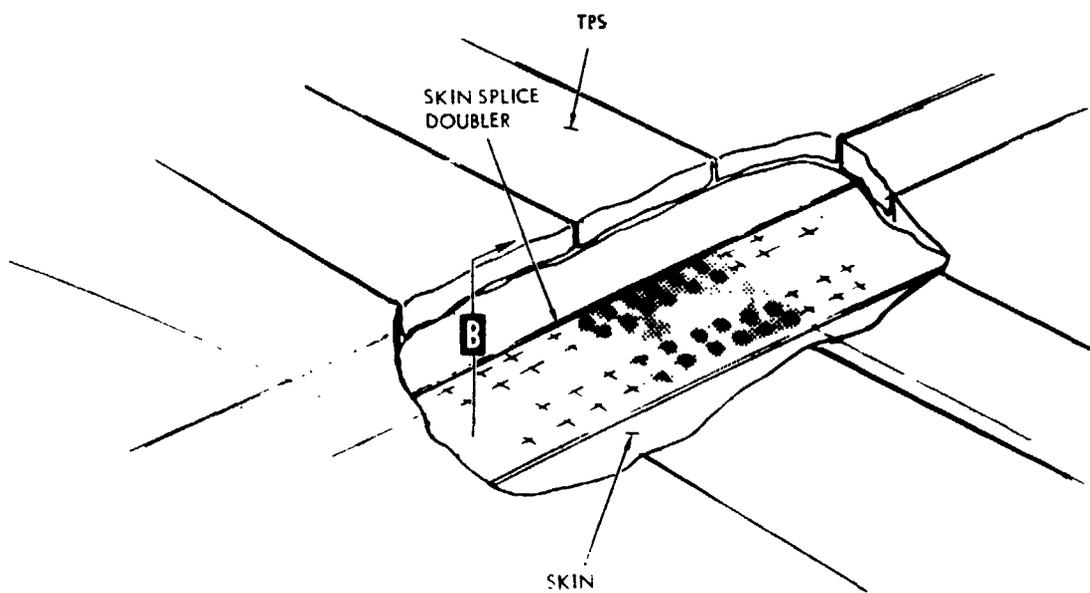
Figure 5-11. Wing Lower Skin Panels (Sheet 1 of 2)

COMPONENT/AREA DESCRIPTION: WING LOWER SKIN PANELS: The skin lower surface panels may be subject to fatigue damage in the areas where highly loaded wing spars and ribs intersect. Of particular interest are, generally, the areas of skin where the Y_w 254, 226, 198, 167 and 114 ribs intersect the X_w 1365, 1307, 1249, 1191, 1132 and 1047 spars. The critical load conditions are high compression during high-Q boost and tension during cruise headwinds; compressive loads during landing may also contribute. The skins are made of 2024-T81 formed sheet covered externally with the HRSI/LRSI TPS and reinforced in a fail-safe design approach by the use of stringers.

DEFECTS: Fore-to-aft cracks (chordwise) emanating at fastener holes in the skin along the spar rib intersections.

ACCESS: Enter appropriate wing box area through wing access openings to place x-ray film. X-ray machine is placed on ground or platform outside of wing, aimed at desired area on lower wing surface (not necessary to remove local TPS for primary NDE) Local TPS must be removed for backup inspection.

NDT TECHNIQUES: Primary: X-ray radiography (para. 1.5.6.2)
Backup: Eddy current (para. 1.5.4.4) or fluorescent penetrant (para. 1.5.2.1 Fig. 1-9)

DEFINITION OF NUMBER AND LOCATION OF INSPECTION POINTS TBD FOR UPPER AND LOWER WING SURFACE

A WING SKIN PANEL SPLICE DOUBLER AT RIB/SPAR LOCATIONS

PROCEDURE NO. 5-619, Figure 5-11

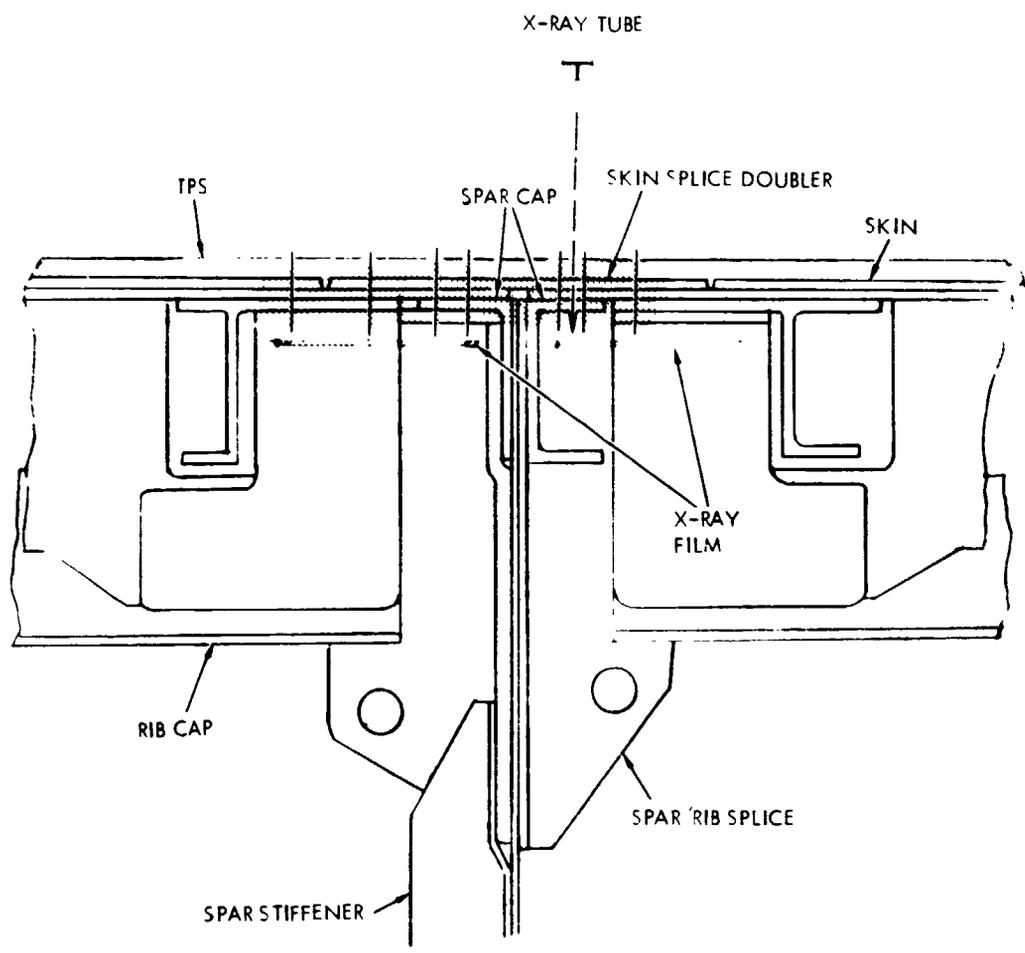
Figure 5-11. Wing Lower Skin Panels (Sheet 2 of 2)

WING SKIN, SPAR RIB INTERSECTIONS, TYPICAL
LKG INBD

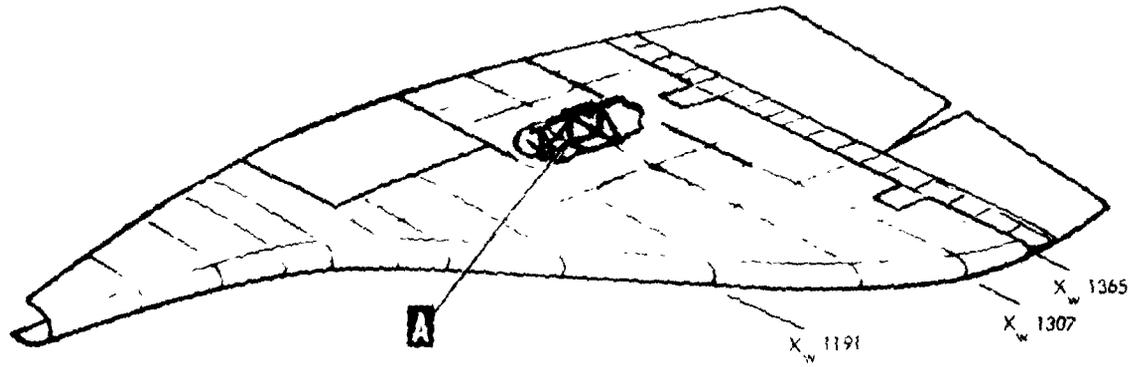
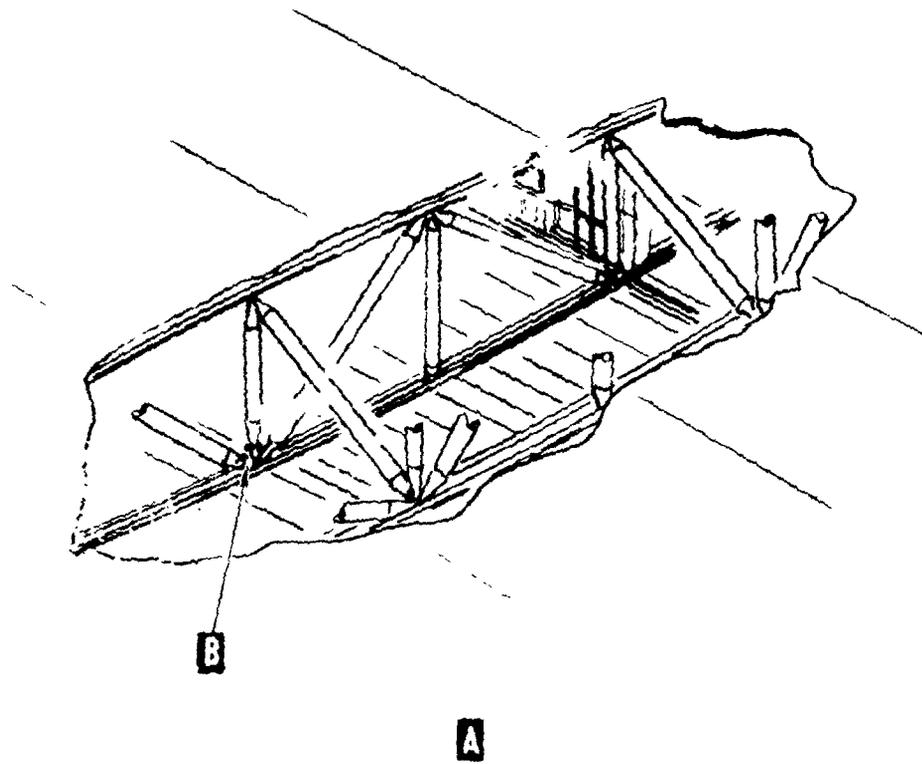
Figure 5-12. Wing Spar Caps (Sheet 1 of 2)

COMPONENT/AREA DESCRIPTION: WING SPAR CAPS: The wing spar caps are made of 2024-T81 aluminum alloy formed sheet and have a zinc chromate primer and Supercorapon 515-700 paint interior surface finish. The caps are subject to damage in the area of rib and spar truss splice attachments due to high tensile loads during high-Q boost, compression and tension during atmospheric flight and landings. The areas that are of particular interest are located at the intersections of highly loaded ribs and spars (such as generally along the X_w 1365, 1307, 1191, 1132, 1040 and leading edge spars and their intersections with the fuselage, Y_w 167, 198, 254, 312 and 342 ribs).

DEFECTS: Spanwise cracks around spar cap-to-splice fitting fastener holes in the vertical web portion of the cap; chordwise cracks around fastener holes in the horizontal flange portion of the caps where attachment is made to skin or splice fittings.

NDT TECHNIQUES: Primary: Eddy current surface probe (para. 1.5.4.4) or ultrasonic surface wave (para. 1.5.5.1) techniques.

PROCEDURE NO. 5-620, Figure 5-12

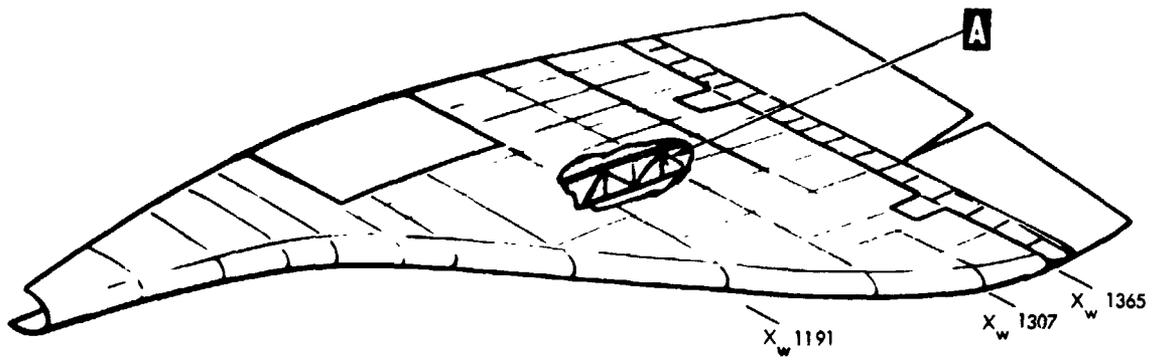
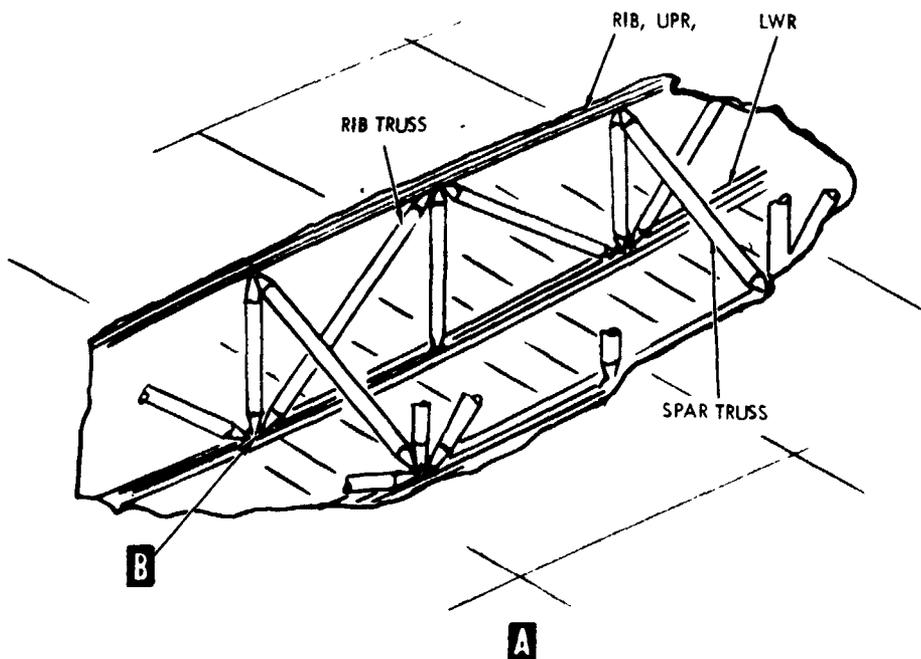
Figure 5-13. Wing Rib Caps (Sheet 1 of 2)

COMPONENT/AREA DESCRIPTION: WING RIB CAPS: The rib caps are made of 2024-T81 aluminum alloy formed sheet and have a zinc chromate primer and Super-corapon 515-700 paint surface finish. The caps are subjected to high tensile loads during high-Q boost and tension/compression during atmospheric flight and landing. The caps may accumulate fatigue damage near certain highly loaded rib/spar splices. In the suspect areas, the caps are sandwiched between the rib/spar attachment flanges and rib channels. The areas are generally along the fuselage intersection, along the wing box rib and loaded ribs intercepting the leading edge spar and the wing aft spar.

DEFECTS: Vertically oriented through-cracks emanating from fastener holes where attachment is made to the rib/spar fitting.

NDT TECHNIQUES: Primary: Radiography (para. 1.5.6.2) (gamma-ray (para. 1.5.6.3) may be best because of confined space).

WING TRUSS, RIB, TYPICAL

PROCEDURE NO. 5-621, Figure 5-13

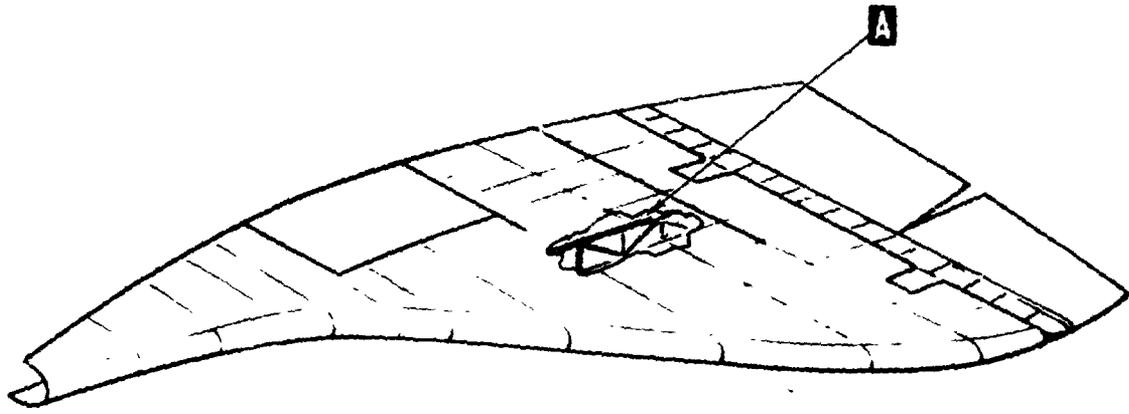
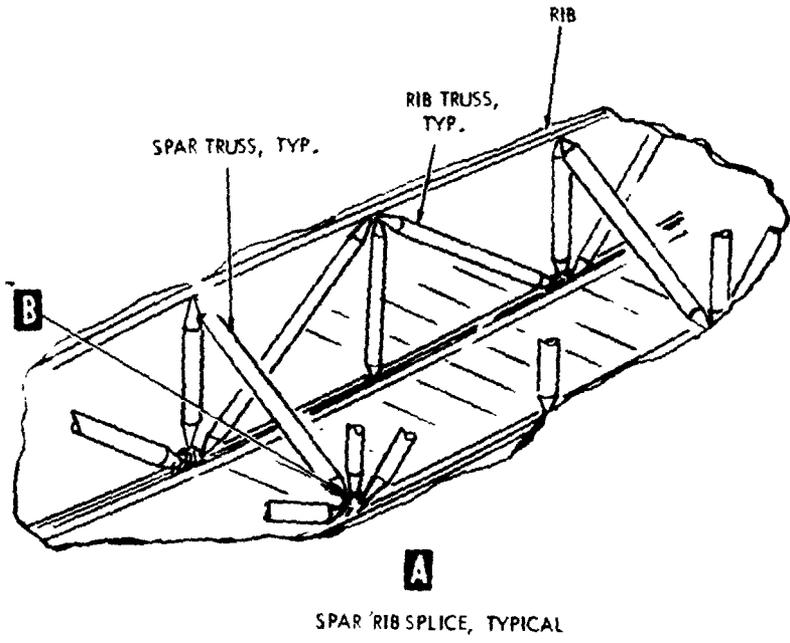
Figure 5-14. Wing Spar/Rib Splices (Sheet 1 of 2)

DEFECTS: Radial cracks in the truss attachment lugs; vertically oriented cracks emanating from fastener holes on the rib and spar attachment flanges; and edge cracks where the rib truss attachment flanges blend into the spar truss attachment flanges.

NDT TECHNIQUES: Primary: Radiographic (para. 1.5.6.2) (gamma ray (para. 1.5.6.3) source may be best due to confined area); eddy current surface probe (para. 1.5.4.4) for flange edge cracks.

Backup: Eddy current (para. 1.5.4.4) or penetrant (para. 1.5.2.1 Fig. 1-9) after removal of suspected truss and/or fastener.

PROCEDURE NO. 5-622, Figure 5-14

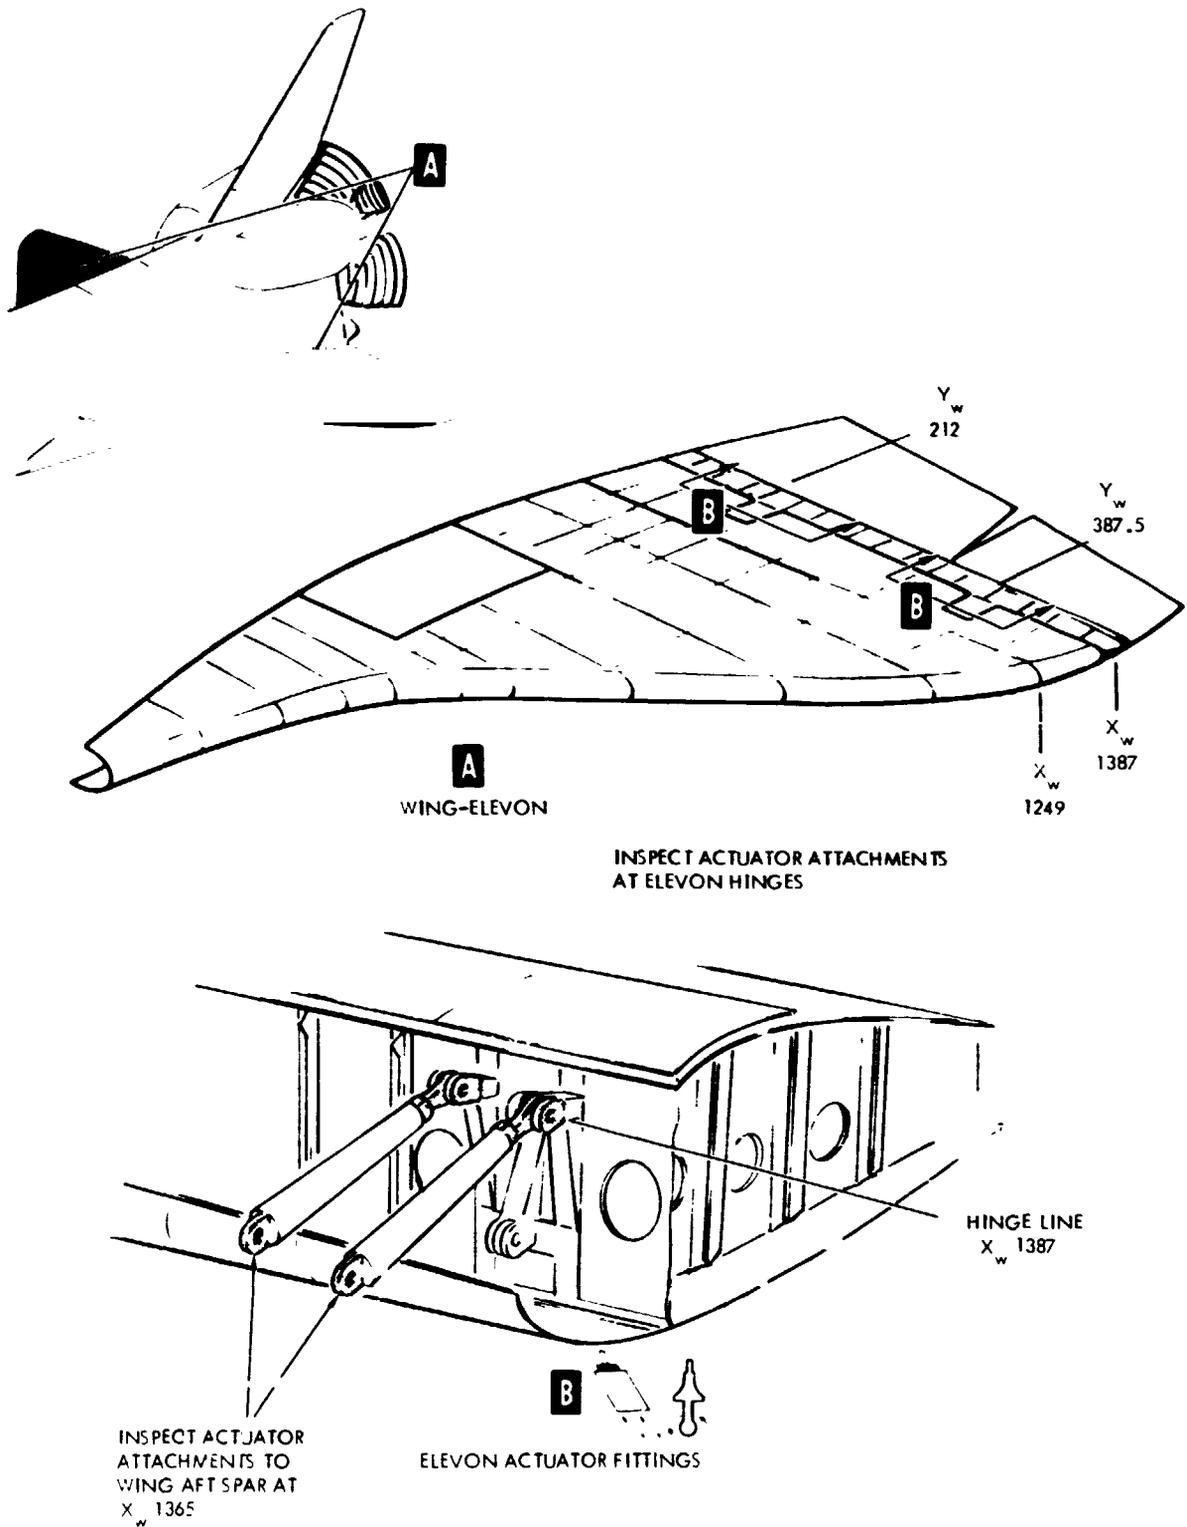
Figure 5-15. Elevon Actuator Attach Fittings

NDT TECHNIQUES: Primary: Ultrasonic shear wave (para. 1.5.5.3 B) and eddy current surface probe (para. 1.5.4.4).

Backup: Eddy current bolt hole (para. 1.5.4.3) and fluorescent penetrant (para. 1.5.2.1 Fig. 1-9).

PROCEDURE NO. 5-623, Figure 5-15

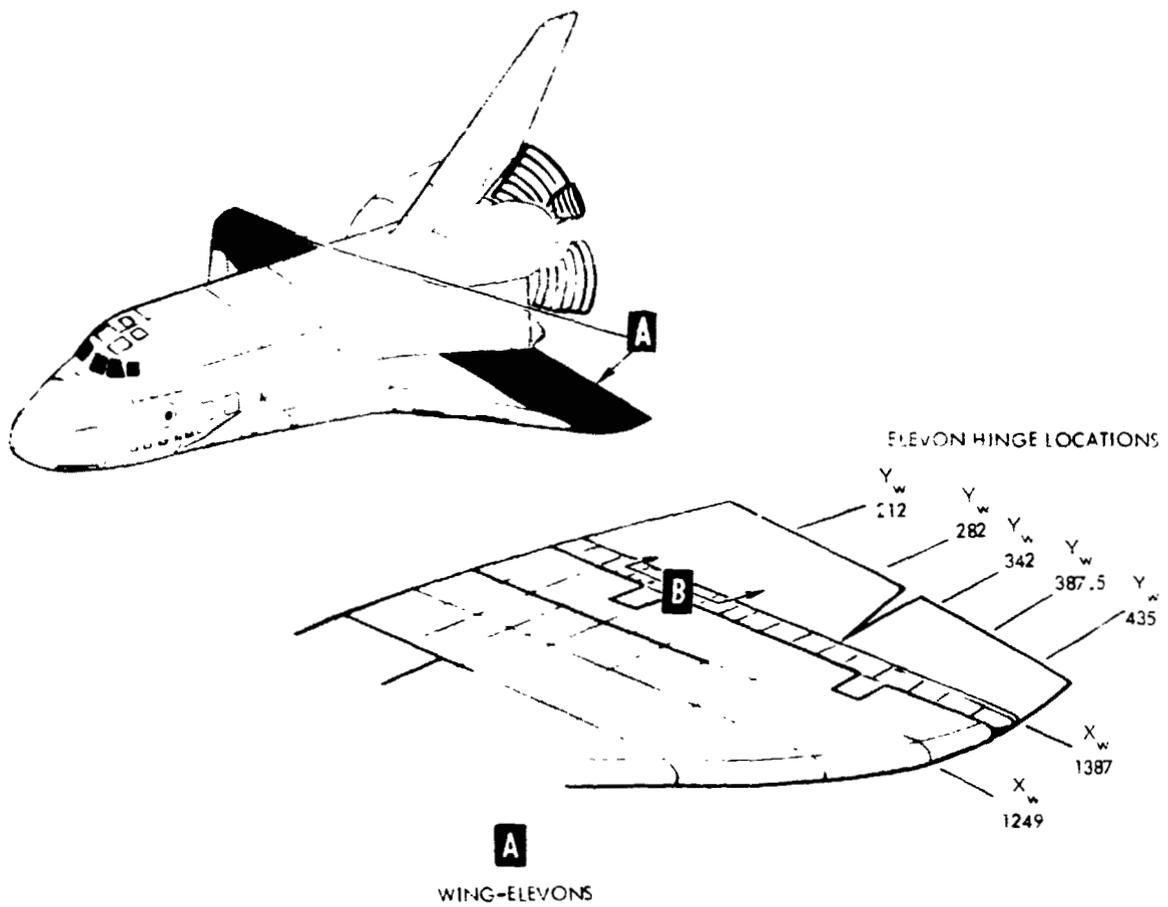
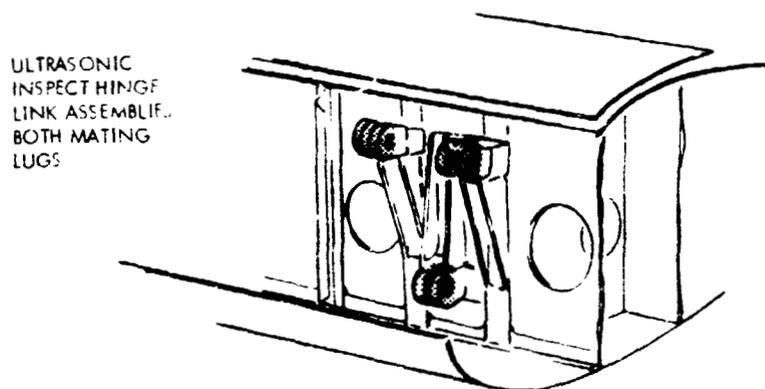
Figure 5-16. Elevon Hinges

NDT TECHNIQUES: Primary: Ultrasonic shear wave (para. 1.5.5.3 B) and fluorescent penetrant (para. 1.5.2.1 Fig. 1-9).

Backup: Eddy current bolt-hole (para. 1.5.4.3) or fluorescent penetrant (para. 1.5.2.1 Fig. 1-9).

ELEVON HINGE AND ACTUATOR FITTINGS, TYPICAL

PROCEDURE NO. 5-624, Figure 5-16
